Subject: **Comments on the 2006 303(d) List**

## Harding Drain

### New Harding Drain Data Support Delisting

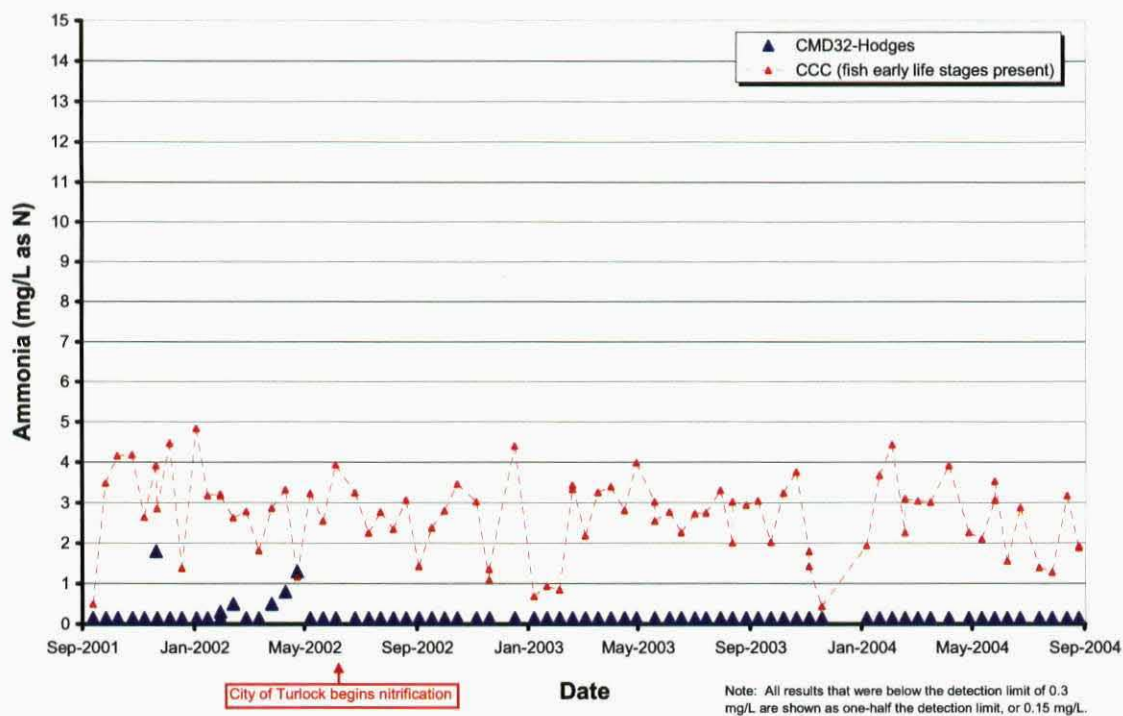
**Figure A1. Ammonia in Ceres Main Canal Upstream of Harding Drain (CMD32-Hodges) with CCC Limit.**

**TID Data.** Ammonia concentrations at CMD32-Hodges, shown in Figure A1, which are upstream of the RWQCF effluent discharges, show only one exceedance of chronic ammonia criteria out of 72 samples collected. The delisting criteria in the Policy (Table 4.1) would allow for as many as six total exceedances over that sample size and still reject the null hypothesis (that the site is impaired for ammonia). These data more than meet the delisting criteria. Raw TID ammonia data for CMD32-Hodges are available in Section 5.0 of this document.

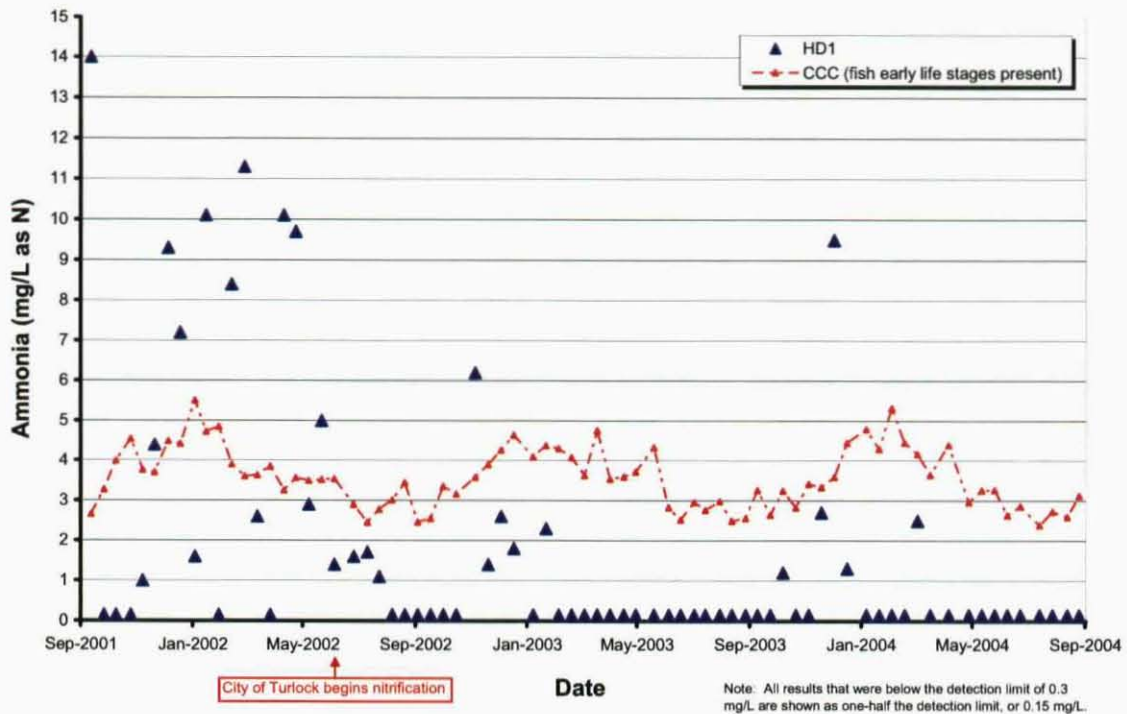
**Figure A2. Ammonia at the Upstream End of Harding Drain (HD1) with CCC limit.**

**TID Data.** Ammonia concentrations at HD1, shown in Figure A2, are influenced by the RWQCF effluent. Prior to the RWQCF treatment improvement, a total of 10 out of 19 samples (53%) exceeded the CCC limit at HD1. However, only 2 exceedances out of 55 samples (4%) were observed after the RWQCF upgrade. Data collected after the upgrade more than meet the delisting criteria, which would allow for as many as four exceedances of

the CCC and still support delisting. Raw TID ammonia data for HD1 are available in Section 5.0 of this document.

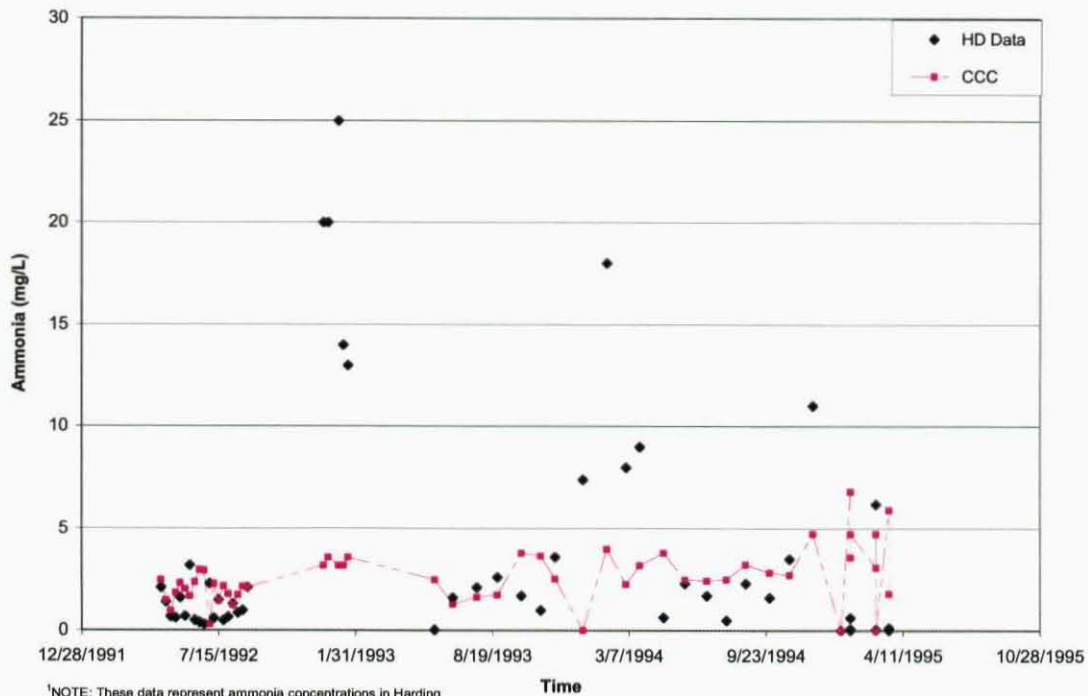
**Figure B1. USGS NAWQA Phase I Ammonia Data and CCC Limit for Harding Drain at Carpenter Road (before RWQCF upgrades)**

**USGS NAWQA Phase I Data.** The USGS collected ammonia data for Harding Drain near HD2 between 1992 and 1995 as part of NAWQA Phase I monitoring. These data indicate water quality impairment that was present prior to the City of Turlock upgrade of the RWQCF, with 20 out of 58 ammonia samples exceeding the CCC (see Attachment B for data and plots).

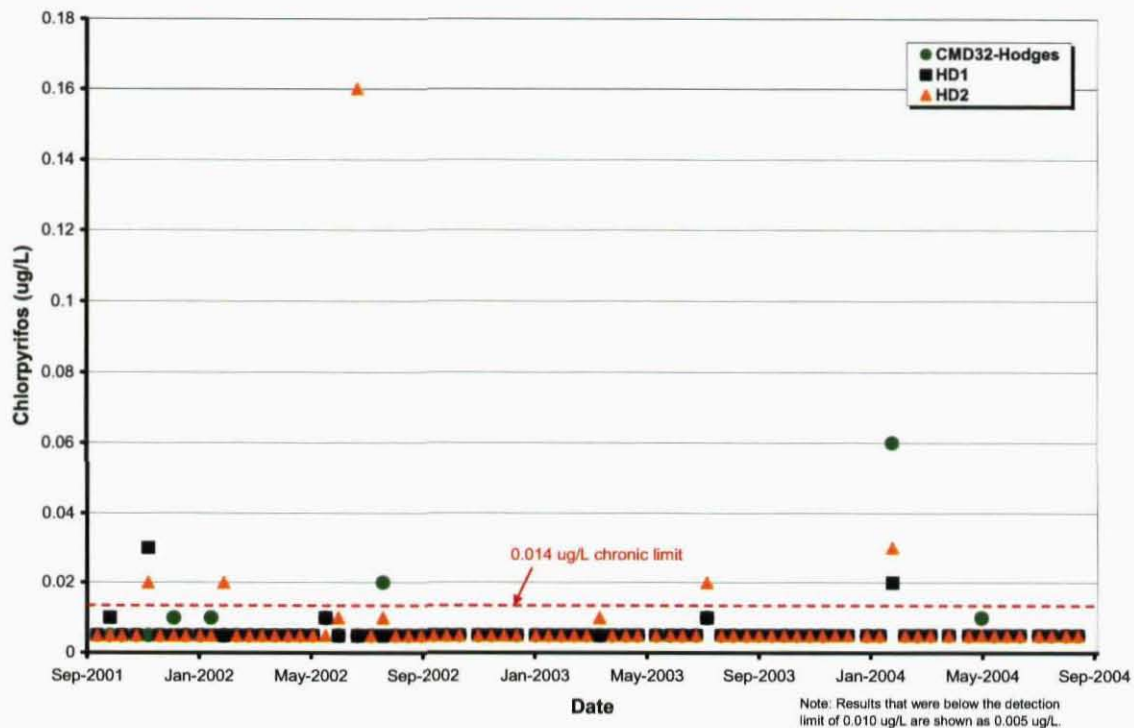
**Figure C1. Chlorpyrifos in Ceres Main Canal and the Harding Drain with Numerical Limit of 0.014 ug/L**

**TID Data.** As shown in Figure C1, chlorpyrifos data, collected by TID from September 2001 through September 2004, show two exceedances of the chronic limit (0.014 ug/L) out of 71 samples collected at CMD32-Hodges, two out of 74 samples collected at HD1, and five out of 74 samples collected at HD2. The delisting criteria would allow for up to five exceedances at CMD32 and up to six exceedances at HD1 and HD2. Taken together, data from all three sites also support delisting, with a total of nine exceedances out of 219 samples, when the delisting criteria would allow up to 18 exceedances to support delisting. TID chlorpyrifos data for CMD32-Hodges, HD1, and HD2 are included in Tables C1, C2, and C3, respectively, in Section 5.0 of this document.

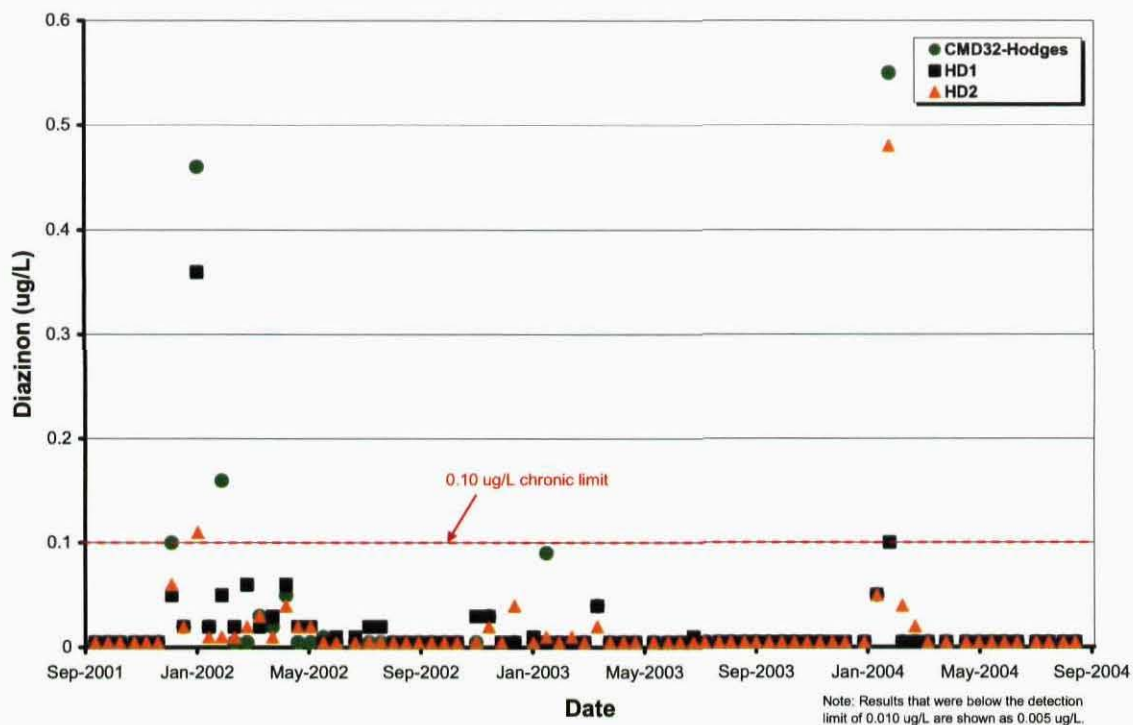
**Figure C2. Diazinon in Ceres Main Canal and the Harding Drain with Numerical Limit of 0.10 ug/L**

**TID Data.** Diazinon data collected by TID at CMD32-Hodges, HD1, and HD2 are presented in Figure C2. The diazinon data show four exceedances of the chronic limit (0.10 ug/L) at CMD32, and two each at HD1 and HD2, which meet delisting criteria. The delisting criteria in the Policy (Table 4.2) would allow for up to five exceedances at CMD32 and up to six exceedances at HD1 and HD2. Taken together, data from all three sites also support delisting; though 18 exceedances would be allowable under the Policy, a total of only eight exceedances out of 219 samples were observed.

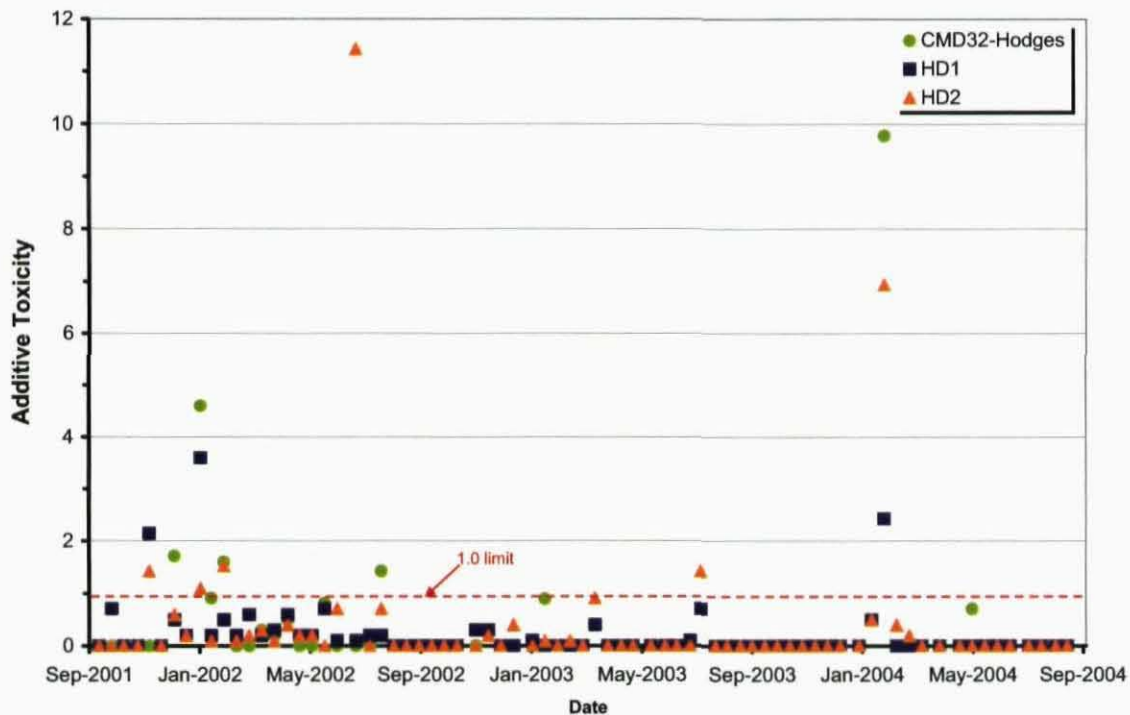
**Figure C3. Additive toxicity of Chlorpyrifos and Diazinon in Ceres Main Canal and the Harding Drain**

Additive toxicity was calculated for each of the three sampling locations using the chlorpyrifos and diazinon data collected by TID (Figure C3). Five of the 71 samples collected at CMD32-Hodges, 3 of the 74 samples collected at HD1, and 6 of the 74 samples collected at HD2 exceeded the additive toxicity limit. Though additive toxicity is not listed as a 303(d) impairment, these data meet the criteria for delisting chlorpyrifos and diazinon collectively. Of the 219 samples assessed for the three sites, a total of 14 had additive toxicity that exceeded the additive toxicity limit, when the delisting criteria would allow for up to 18 exceedances

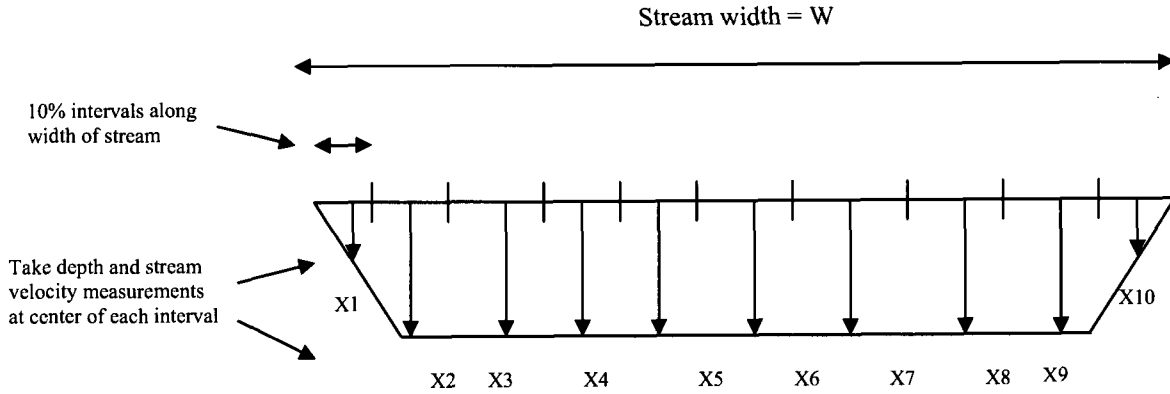
### CROSS-SECTIONAL FLOW MEASUREMENTS

X1 (measured at  $W/20$ ):      Depth = \_\_\_\_\_      Velocity = \_\_\_\_\_
