Cachuma Project Water Rights Hearing

Rebuttal Testimony

Management Reach Overflight Observations

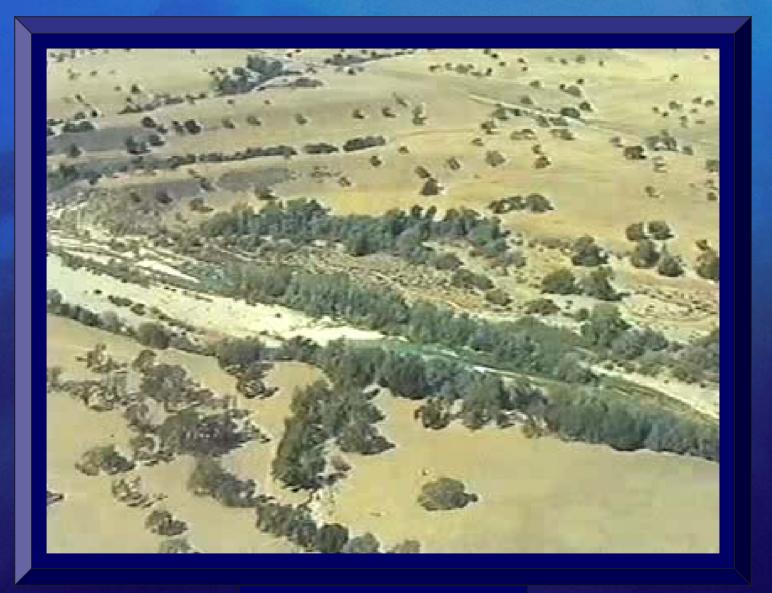
Highway 154 Bridge

- Highway 154 Compliance Point
 - Hwy 154 Reach is flowing
 - Current target flow 1.5 cfs
 - September releases 4 cfs
 - Gravel bar at Hwy 154 Bridge only dry location
