Description and Photo-Documentation of Field Work Activities – Westside Monitoring Station Maintenance

Report 4.1.1

December, 2013

Ecological Engineering Research Program
School of Engineering & Computer Sciences
University of the Pacific
3601 Pacific Avenue
Chambers Technology Center
Stockton, CA 95211

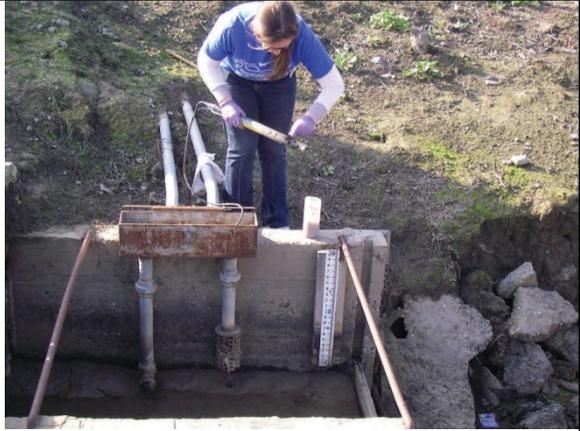
Hospital Creek
Chelsea cleans the sonde.

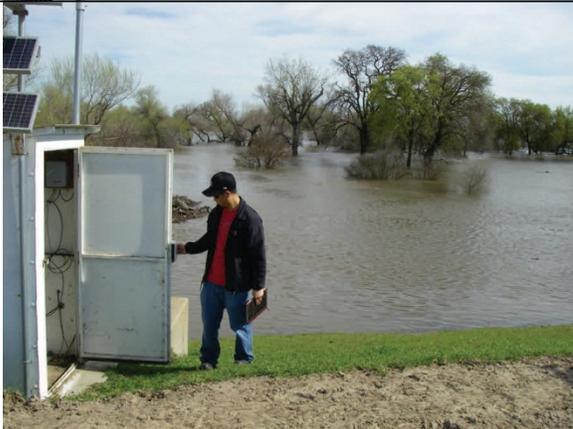
Ramona Lake Drain
Mike examines the flow station at Ramona Lake Drain. Behind him it can be seen that the water level is unusually high.

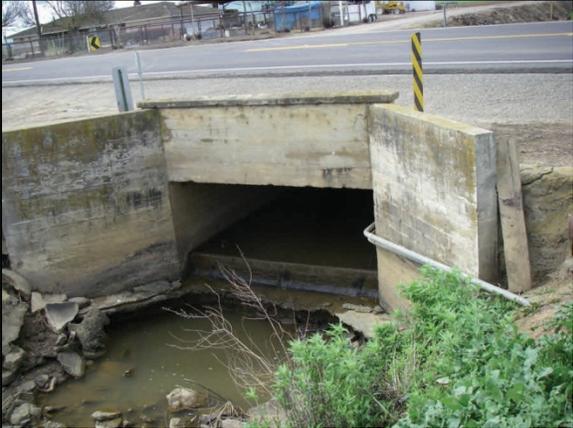
Ingram Creek
There is only a trickle of water at Ingram Creek.

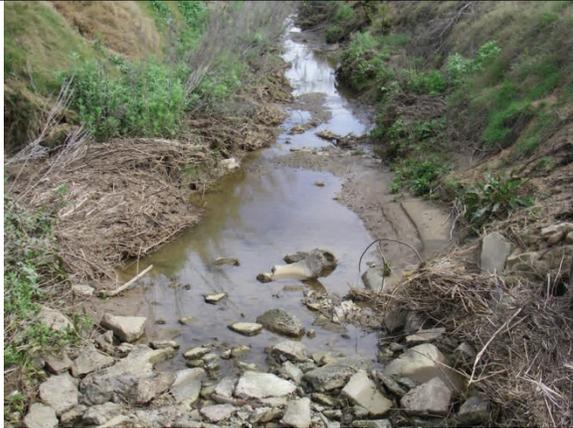
Ingram Creek
There is not enough water to take a QA measurement at Ingram Creek.

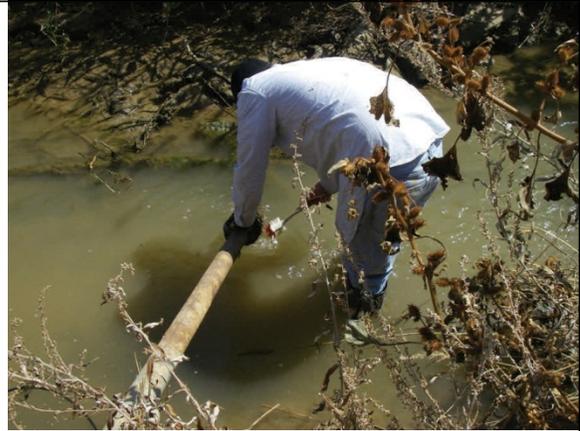
Mike jumps into Ingram Creek to remove debris from the sonde cage.

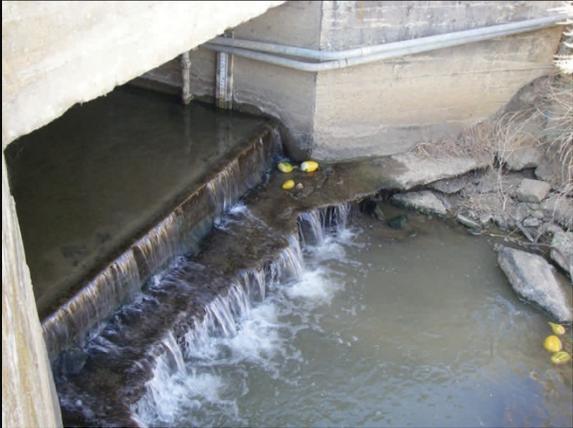
Dredging at Ingram Creek has caused severe erosion of the channel and the water level has fallen below the reach of the sonde. On July 19, 2012 when it was realized that the water level would never return to previous levels, the sonde was removed in order to preserve the sensors as well as prevent theft or vandalism. The sonde will be moved to a new location under the bridge next to the stage sensor in the spring of 2013.

Ingram Creek
The water level at Ingram Creek has fallen below the sonde.

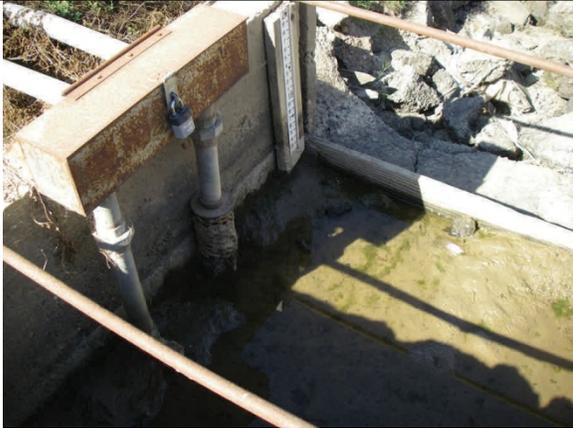
Hospital Creek
There is no flow at Hospital Creek.

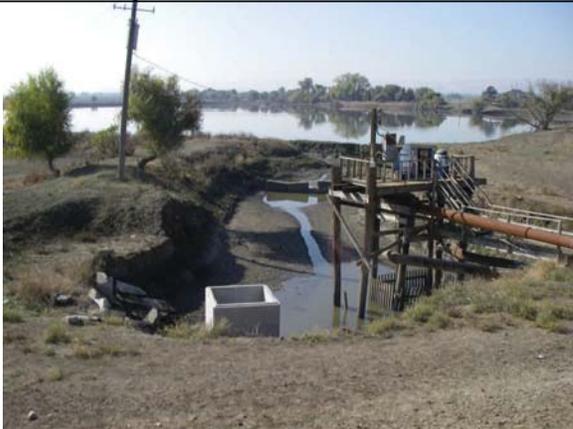
Ramona Lake Drain
The water level at Ramona Lake is unusually low.

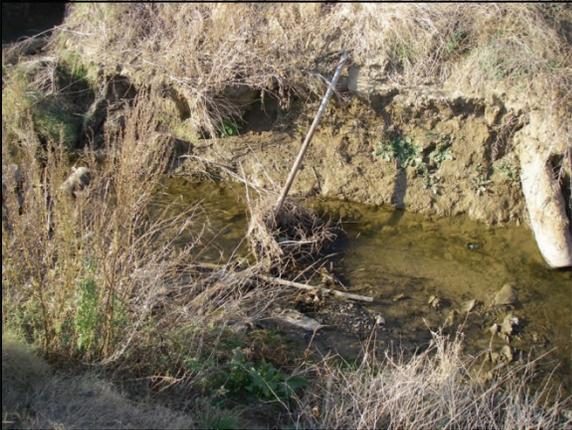
Ingram Creek

The field team removes brush that has collected around the sonde.

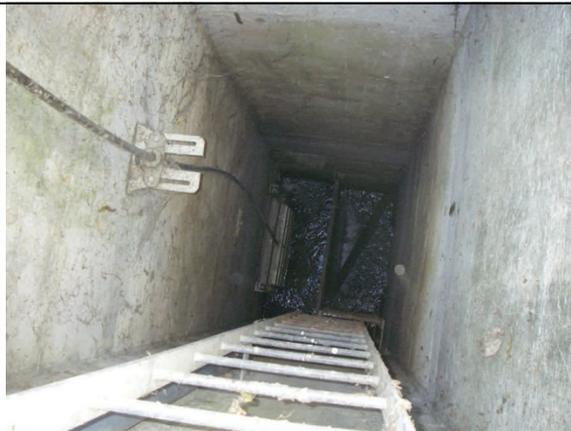
Ramona Lake Drain
It appears that one of the weir boards at Ramona has been knocked out of place.

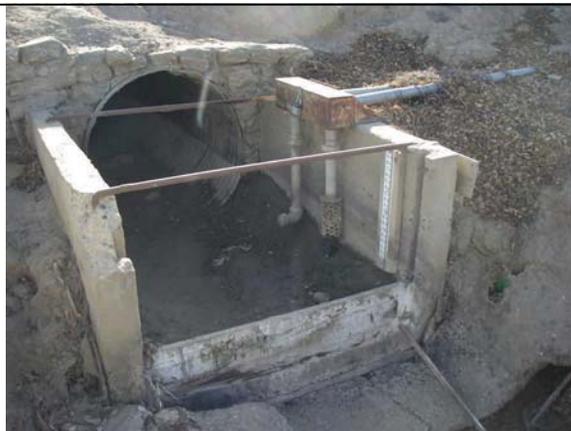
Hospital Creek
Hospital Creek is completely dry.

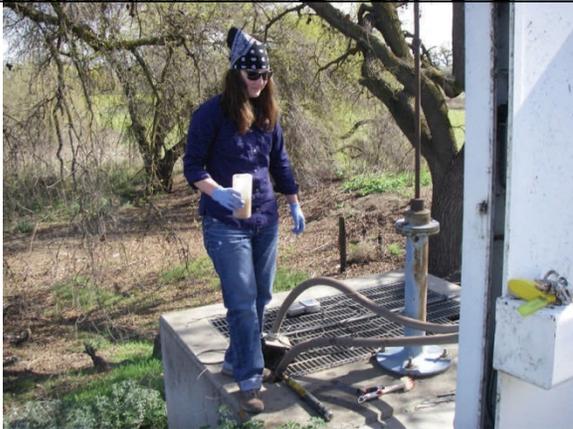
Marshall Road Drain
Ashley fetches clean water; the sonde at Marshall Road Drain is packed in red colored mud.

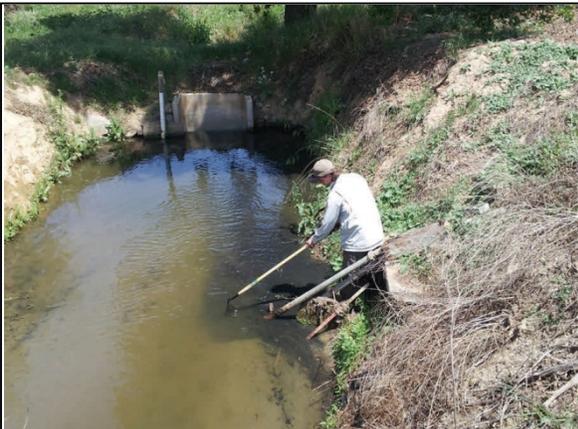
Westley Wasteway

Jeremy removes debris which have collected around the sonde at Westley Wasteway.

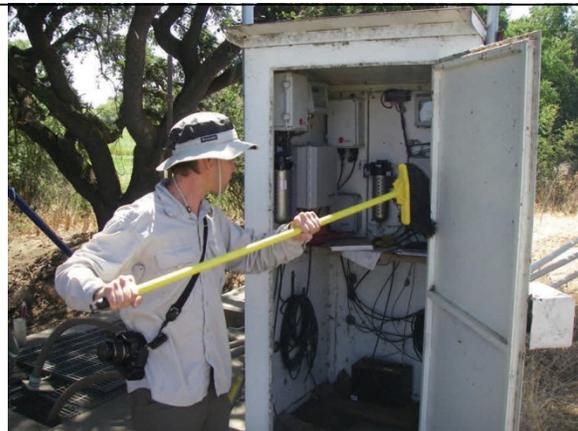
Marshall Road Drain

Jeremy cleans out the station at Marshall Road. Flow stations are often infested with spiders, ladybugs, wasps, and other insects.

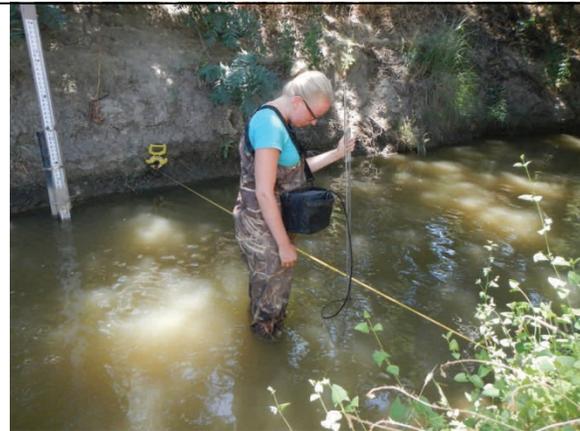
The sonde at Westley Wasteway is infested with some type of insect eggs.

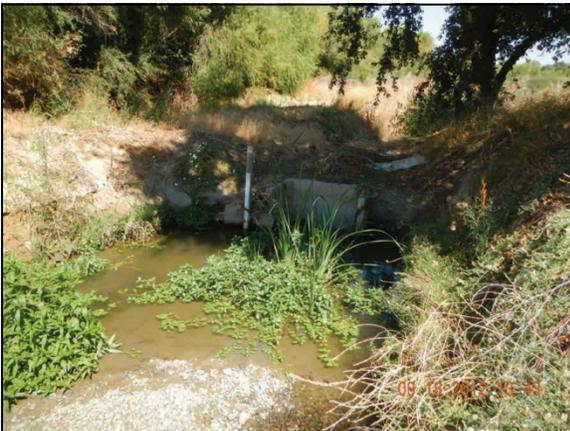
Ingram Creek

Ashley clears the area around the sonde access site.

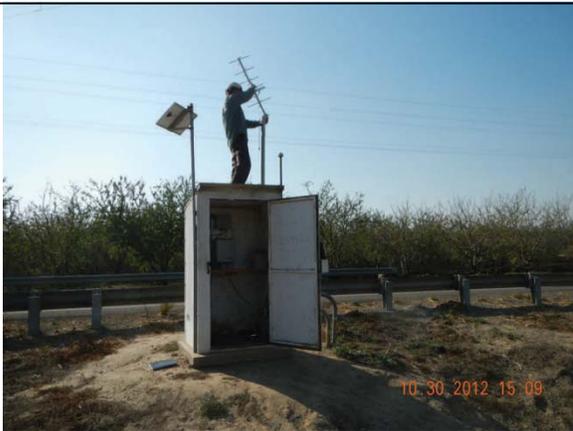
Ingram Creek

Mike and Jeremy investigate whether the sonde can be relocated next to the bubbler at Ingram Creek.
