North Coast Regional Water Quality Control Board

Name and Location of Facility Inspected Saggio Hills, 16840 Healdsburg Avenue Healdsburg, CA, 95448 Construction General Permit WDID #: 1 49C375878 App ID: 470857 CWA Section 401 Water Quality Certification WDID #: 1B06169WNSO		Inspection Date November 29, 2018	Inspection Time 1:00 pm-6:00 pm
Names & Titles of On-Site Representatives and Consultants Chris Theiss – The Robert Green Company Bob Keys – The Robert Green Company Clay Thistle – City of Healdsburg Curt Bates – City of Healdsburg Linda Ruffing – City of Healdsburg Steve Stenson – Advanced Stormwater Protection Kevin Kruizenga – Advanced Stormwater Protection Jim Fane – Carlile/Macy		Consent¹ Provided? Yes <input checked="" type="checkbox"/> No <input type="checkbox"/>	Notified of Inspection? Yes <input checked="" type="checkbox"/> No <input type="checkbox"/>
Regional Water Board Inspector Name & Title Heidi M. Bauer - Engineering Geologist, P.G. Paul Nelson - Engineering Geologist, P.G., C.Hg. Josh Luders - Water Resources Control Engineer Jeremiah Puget - Senior. Environmental Scientist (Specialist) *Referred to as inspection team / staff

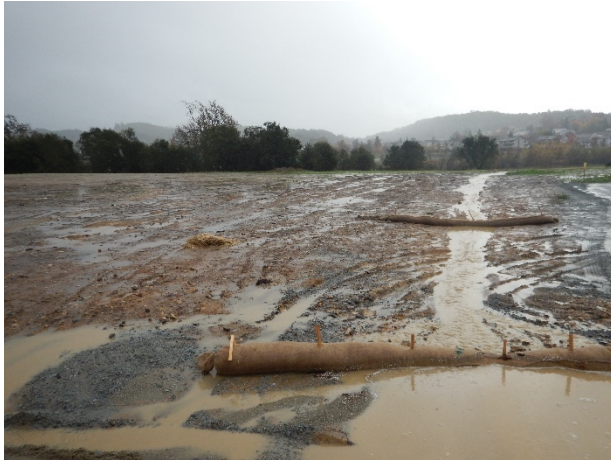
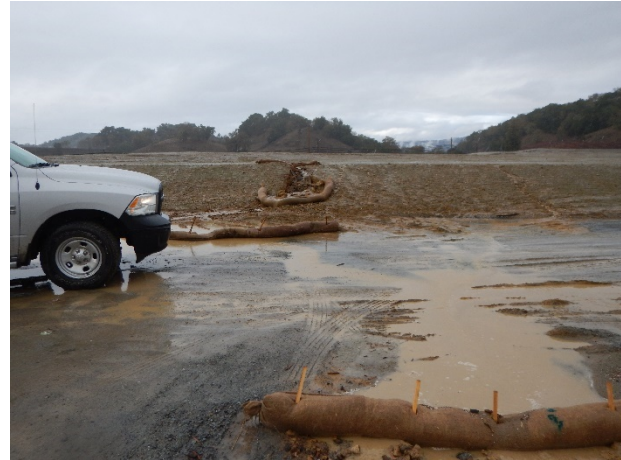
Pictures 3a (left) and 3b (right) above are from the lower Site construction trailer. BMPs are overwhelmed and turbid discharges from this area flow toward the City of Healdsburg detention basin.

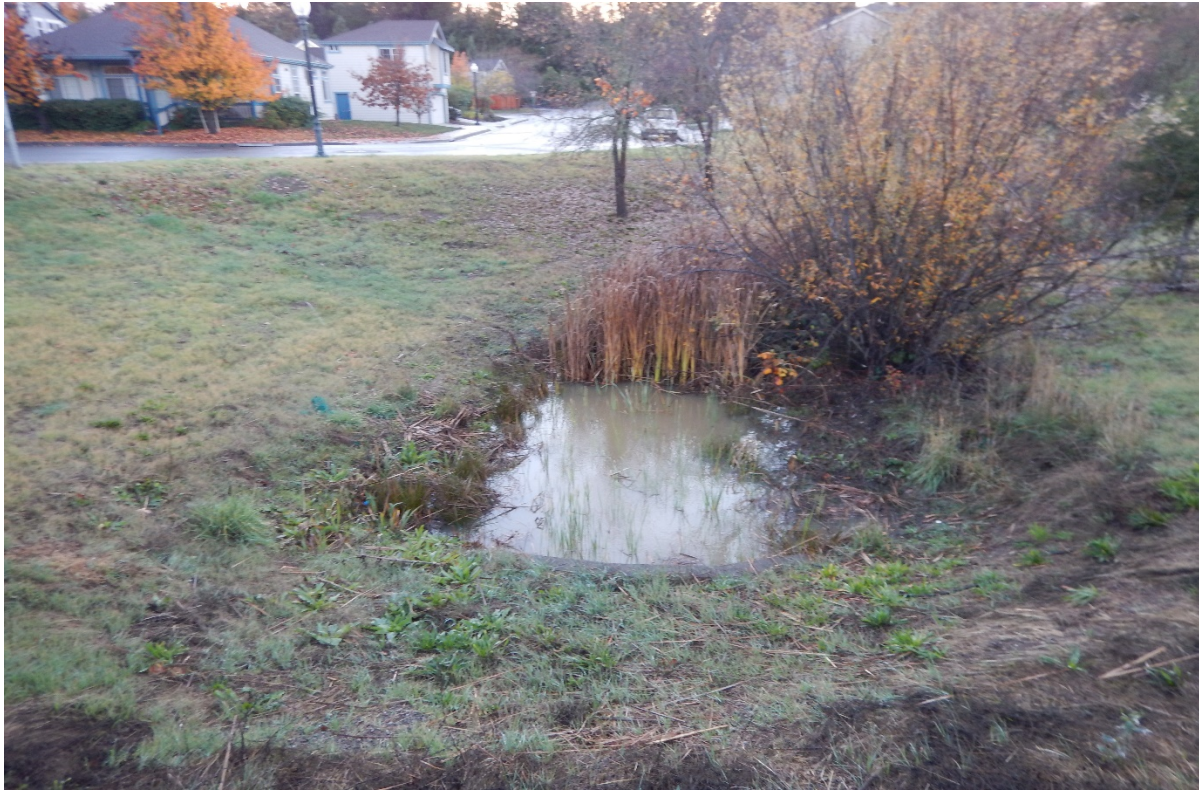
Picture 67 above. Downstream Foss Creek

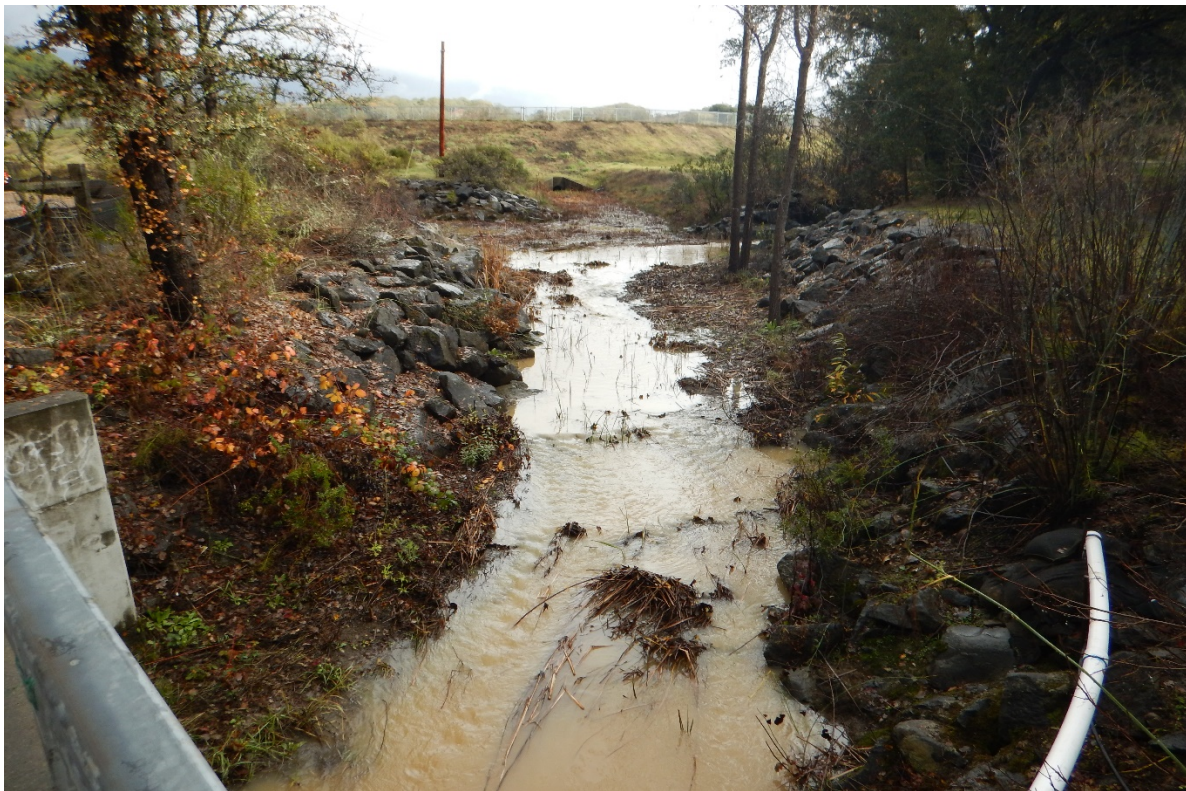
Picture 68 above. Downstream Foss Creek
