North Coast Regional Water Quality Control Board

Subject: Notice of Violation, Directive to Obtain Regulatory Coverage for Cannabis Cultivation, and Transmittal of Inspection Report for July 18, 2019, warrant inspection of Mendocino County Assessor's Parcel No. 032-225-22

File: Cannabis Inspections, Mendocino County, 2019, 190718 Pedro Martinez Garcia 032-225-22, CIWQS Place ID No. 859922

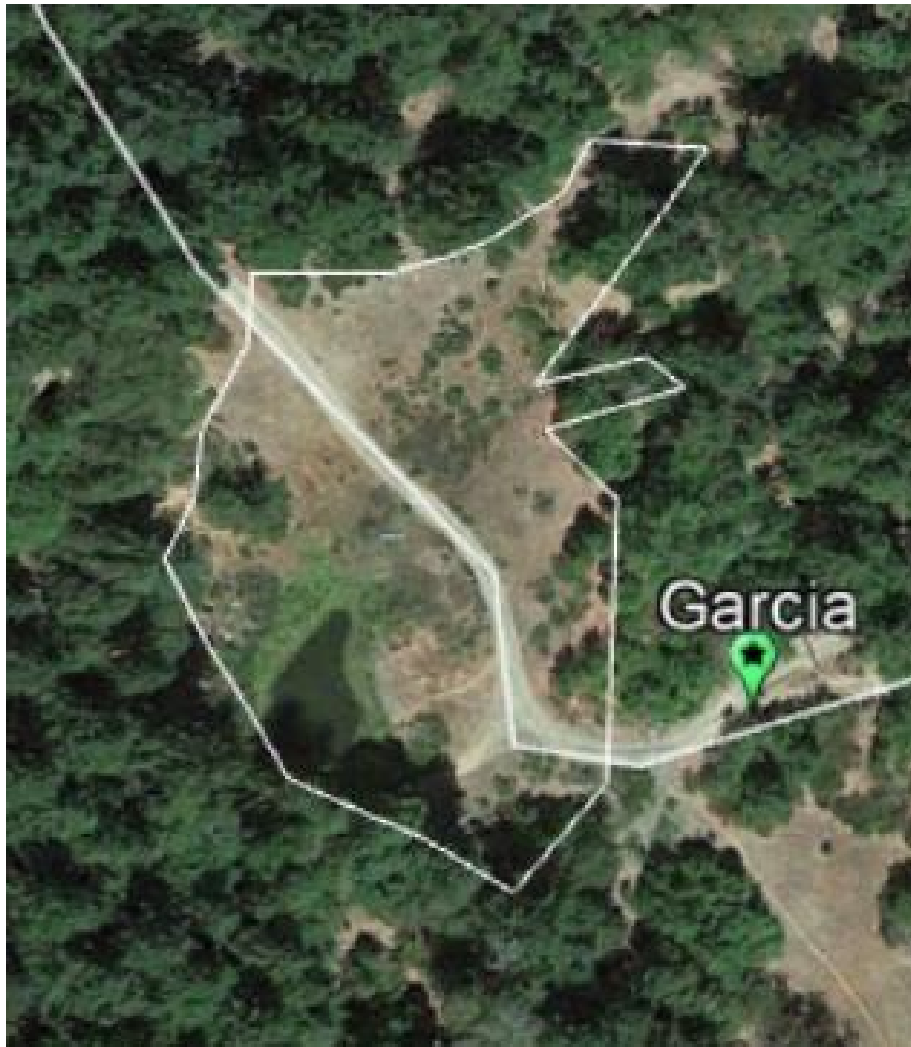
Images below are from Google Earth. Outline shows area of recent ground disturbance in area of Pond (Figure 1)

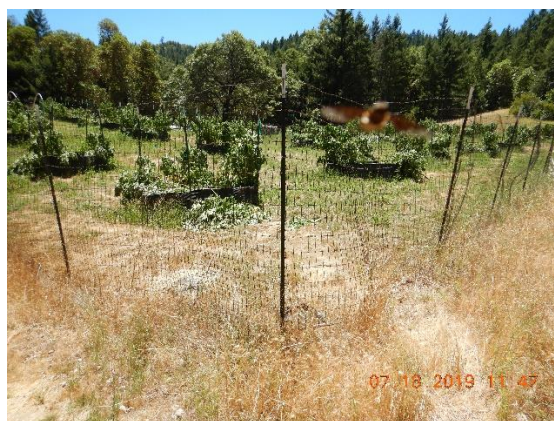
At Outdoor Grow 1 (Photo 1), I measured a cannabis cultivation area of approximately 16,000 ft². I observed hydrophytic plants (*Juncus*) within the cultivation area indicating that the cultivation area had been sited in a wetland area. Aerial imagery from 2009 (see Image 1, below) shows signs of wetland hydrology in this area.

Photo 1 – Outdoor Grow 1

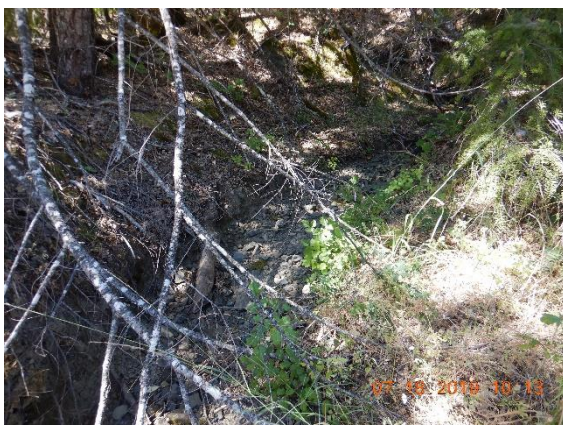
Photo 1.1 – Outdoor Grow 1

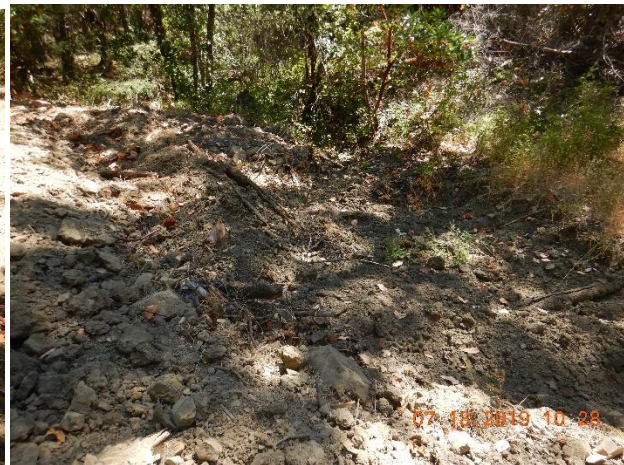
Photo 18-Sediment in Class 3 (Crossing 2)

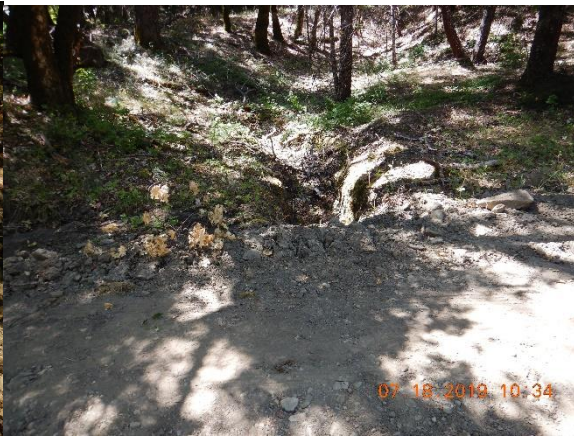
Photo 21 – Sediment in Class 3 (Crossing 2)

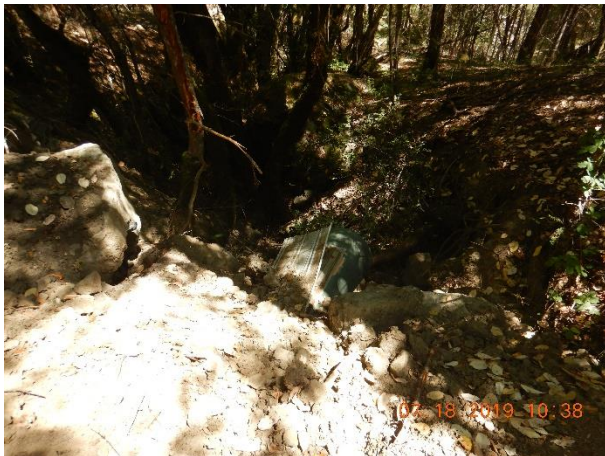
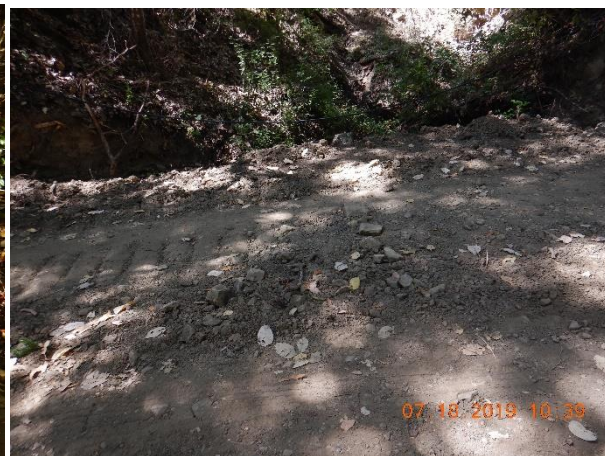
South of Crossing 2, I observed Crossing 3 (Figure 3, photos 22-25), also comprised of earthen fill placed in a watercourse with no culvert or other installed stream crossing. Here, again, I observed evidence of recent heavy equipment work within the channel (photo 25). The volume of fill placed in this watercourse (photos 24-26) was approximately 240 ft³, based on field measurements.

Photo 24 – Sediment in Class 3 (Crossing 3) Photo 25 – Sediment in Class 3 (Crossing 3)

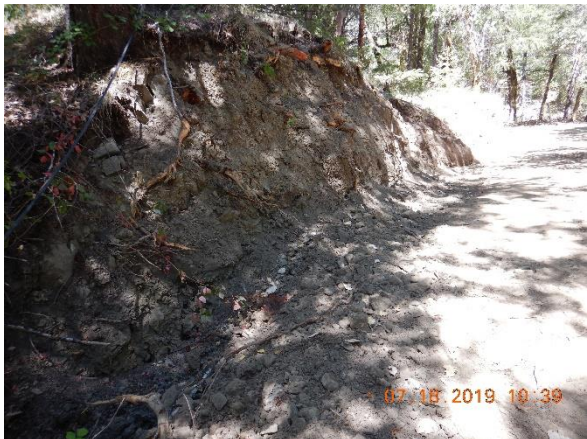
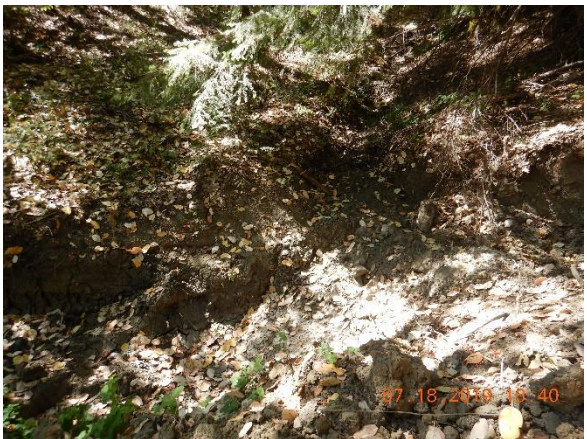
About 200 feet southeast of Crossing 3, I observed Crossing 4 (Figure 3, photos 26-29), a Class III crossing showing signs of recent earthwork. I did not take measurements of the volume of fill at this crossing due to time restraints. I observed a culvert protruding out from the downstream end of the filled road prism, approximately 2-3 feet above the channel bottom (Photo 26). The culvert was undersized for the size of the channel. The upstream end of the culvert appeared to be buried. Like the other crossings in this area, I saw earthen fill extending into the watercourse channel beyond the roadway (photo 26).

Photo 28 –Upstream culvert buried Crossing 4 Photo 29 – Upstream culvert buried Crossing 4

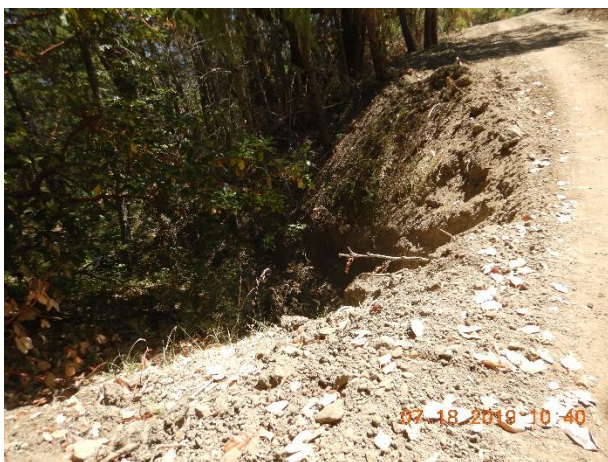
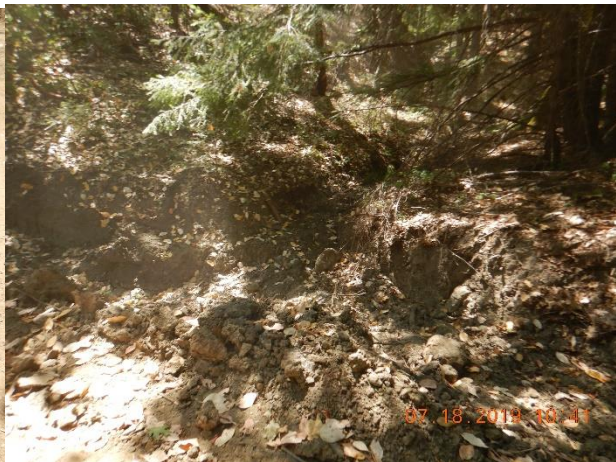
Photo 30 –Erosion from steep unstable cuts Photo 31 – Class 3 watercourse (Crossing 5)

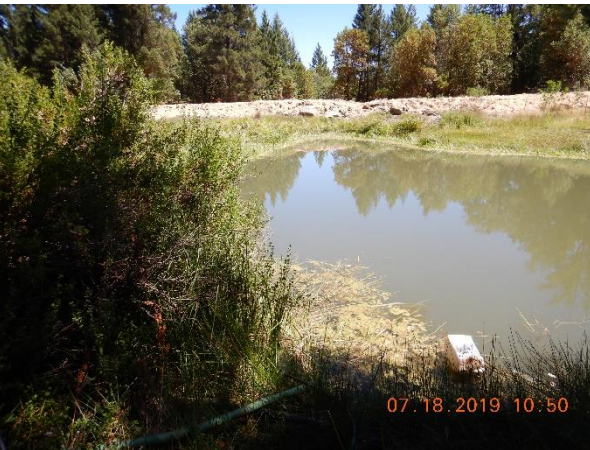
Photo 36 – White container in pond

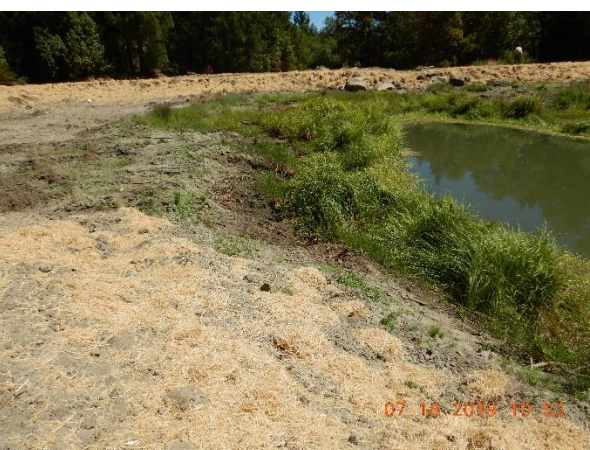
Photo 38 – Chemicals on pond edge

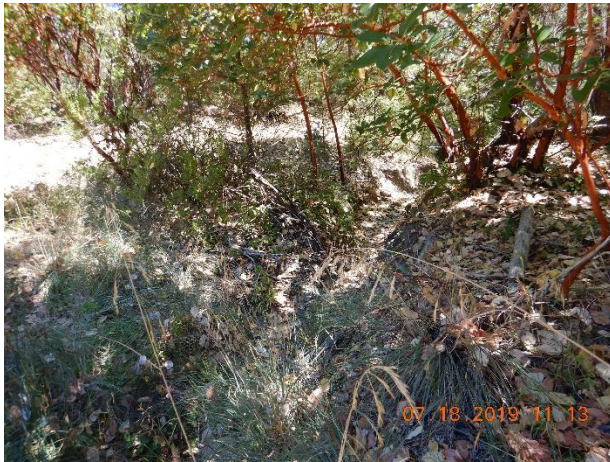
To the west of the pond I observed Crossing 6, with a 32" cement culvert that appeared undersized when compared to the channel (photos 46, 47). I also noticed sediment deposited into the watercourse here (photo 48), likely associated both with the recent earthwork and with drainage from the hydrologically connected roadside ditch (photos 46, 47, 49).

Photo 47 – Fine sediment deposits from pooled water showing impeded flow (upstream Crossing 6)

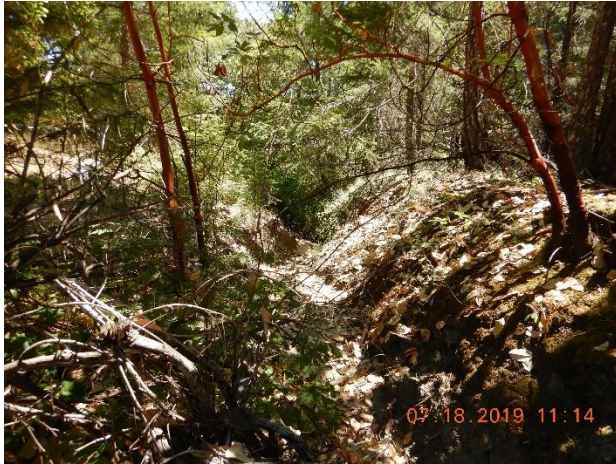
Photo 49 – roadside ditch leading to Crossing 4 showing sediment transport.

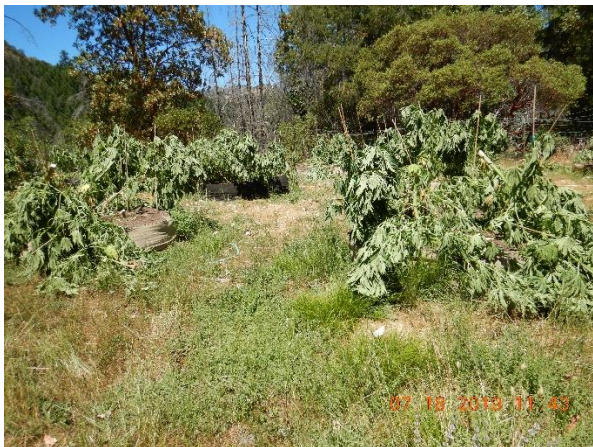
Photo 53 –Outdoor cultivation area in potential wetland ("Outdoor Grow 2" on Figure 5)

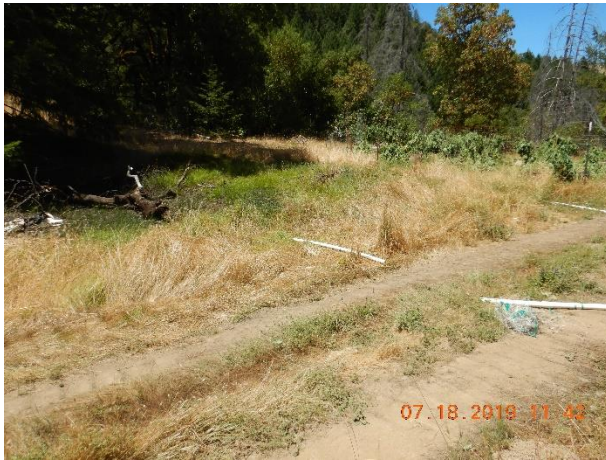
Photo 54 –Outdoor cultivation area in potential wetland (“Outdoor Grow 2” on Figure 5)

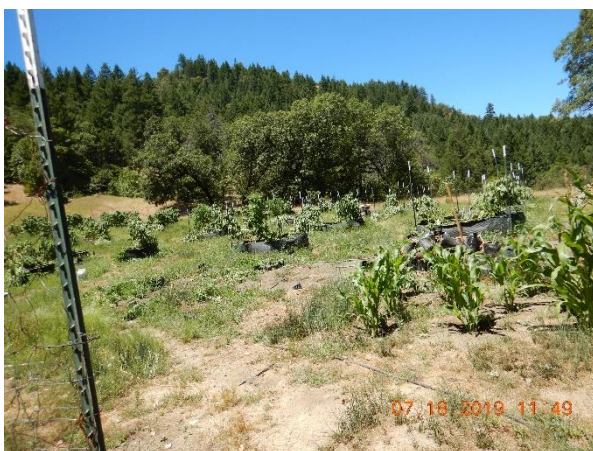
Within the stream channel, I observed trash and chemical containers. One nutrient container was hanging up, indicating it may have been used to mix nutrients within the watercourse. (“Tsh n channel” and “Chems n channel,” photos 55, 56 and 63).

Photo 56 –Outdoor cultivation area in potential wetland (“Outdoor Grow 1” on Figure 5)

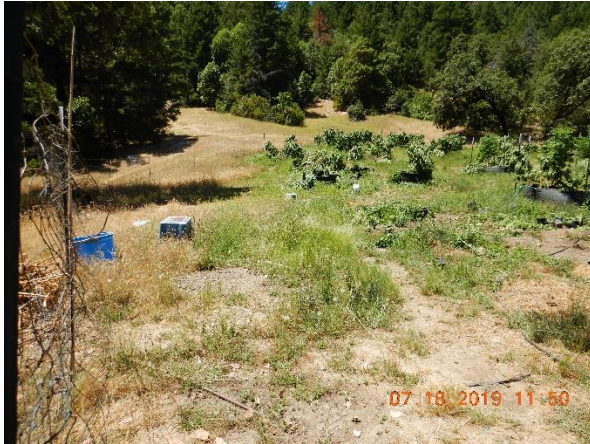
Photo 57 –Outdoor cultivation area in potential wetland (“Outdoor Grow 1” on Figure 5)

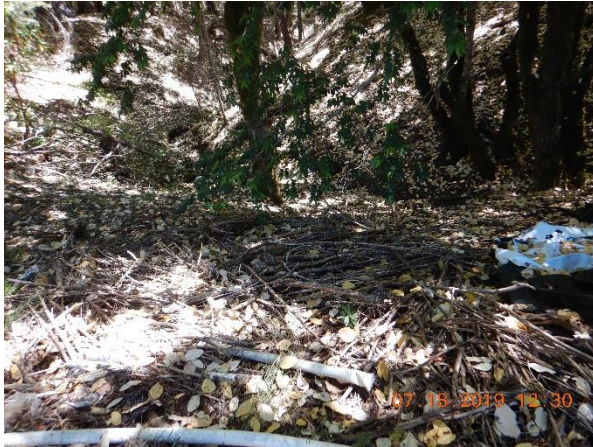
4. Spoils management: I observed potting soil and slash on the banks of the Class II watercourse, in areas where they could enter or be transported into the watercourse.

Photo 61 – Trash, slash and potting soil on Class 2 bank (Figure 5)

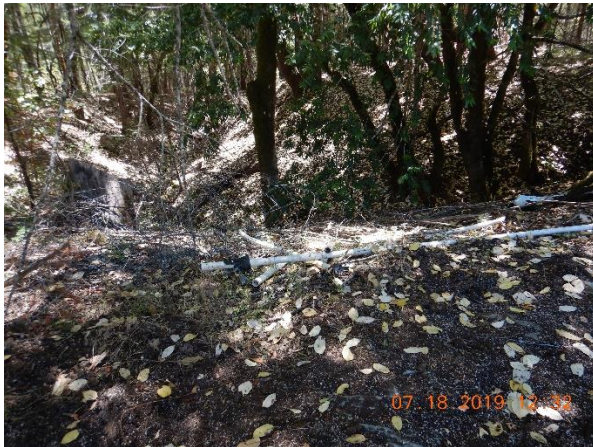
Photo 62 – Trash, slash and potting soil on Class 2 bank (Figure 5)

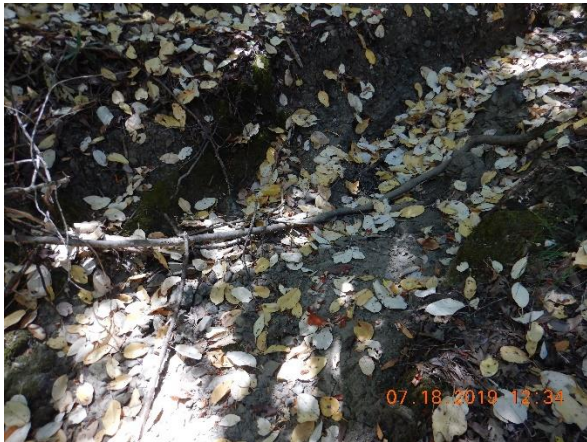
Photo 64 – Sediment in Class 2 watercourse (Figure 5)

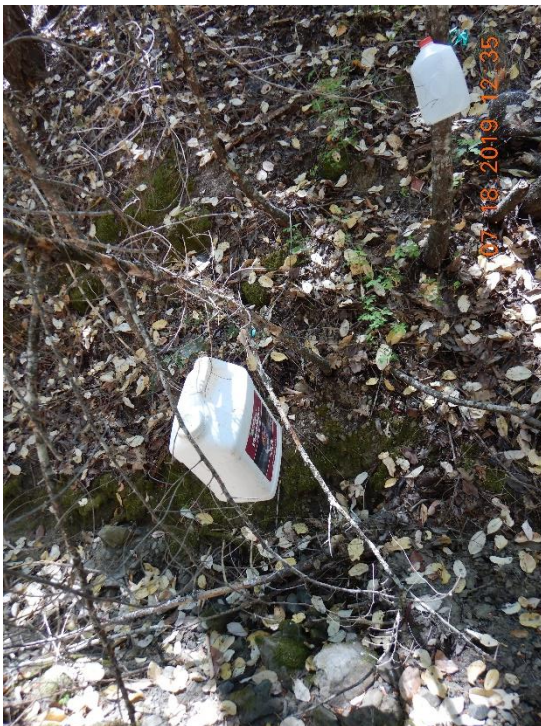
Photo 65 – Nutrients in Class 2 watercourse (Figure 5)

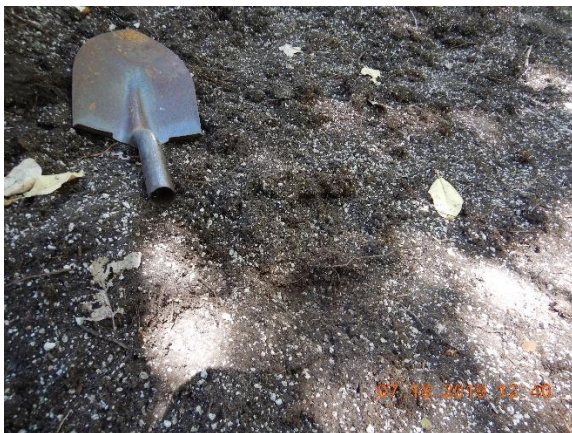
Photo 67 – Amended soil on bank of Class 2 (Figure 5)

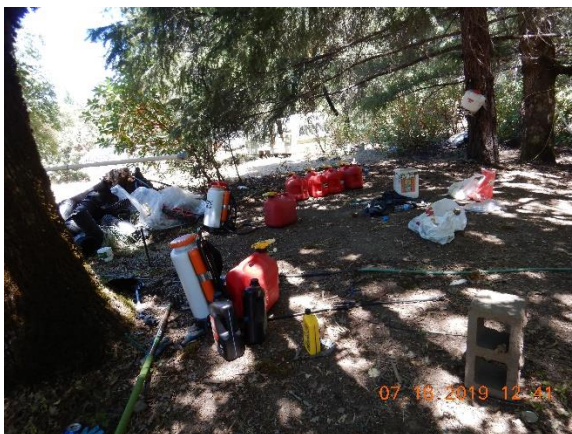
South-southeast of the cultivation area, I observed a number of features of concern, shown on Figure 5. These include chemicals on the ground near the banks of a Class 2 watercourse (“chems,” photos 52, 68, 69); a pile of burned waste (“Burn pile,” photo 59) at a location where material could be transported into the watercourse; and trash, slash and potting soil along the banks of the watercourse (“Tsh” and “Ptg soil,” photos 60, 61, 62, 67, 70, 71, 72, and 73). In this area, I also observed a decrepit, deteriorating RV trailer (“old RV”) within 25 feet of the watercourse bank.

Photo 68 – Trash, fuels and chemicals adjacent to Class 2 (Figure 5)

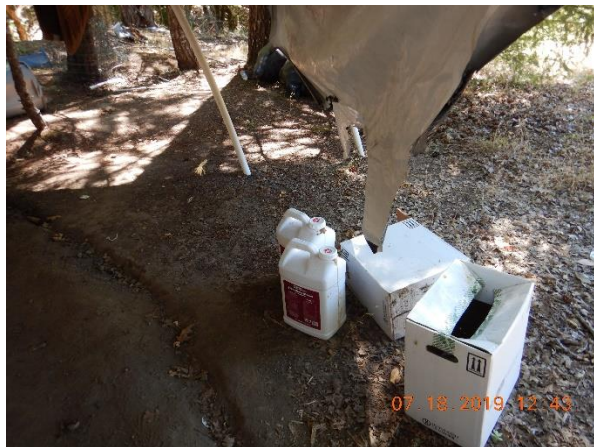
Photo 69 –Nutrients adjacent to Class 2 (Figure 5)

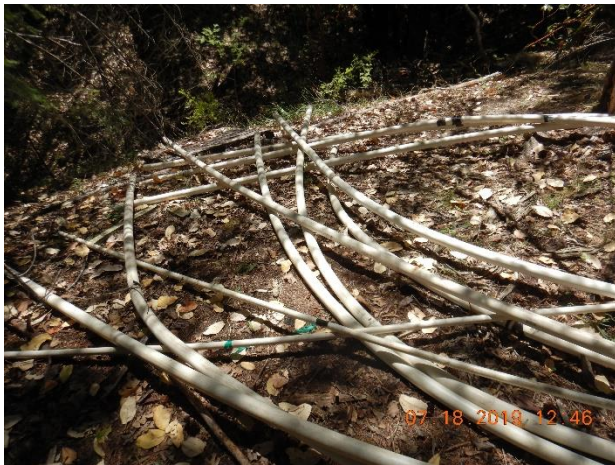
Photo 73 –Trash on bank of Class 2 watercourse (Figure 5)
