Buena Vista Force Main Wastewater Discharge to Buena Vista Lagoon March 31-April 2, 2007

REVISED FINAL REPORT

***24-in Ductile Iron Force Main Failure
Buena Vista Lagoon
Carlsbad, California***

**CITY OF CARLSBAD
24-INCH DUCTILE IRON FORCE MAIN FAILURE
BUENA VISTA LAGOON
Carlsbad, California
NCRU: 01-0743.02 & 01-764.02:ebecker**

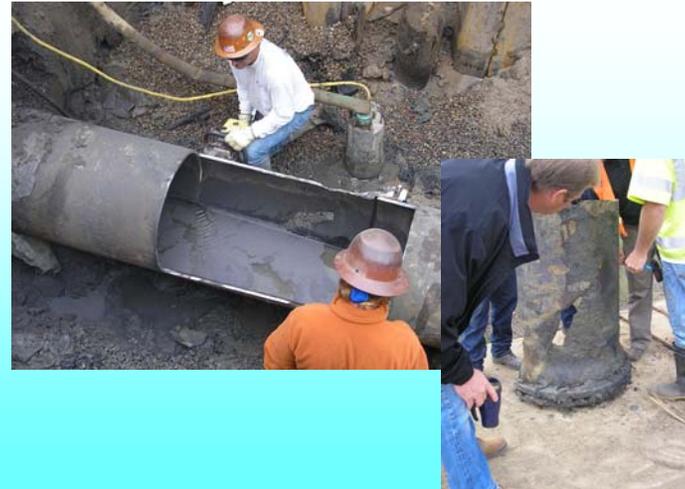
- A rupture to a 24-inch ductile iron force main occurred between the Jefferson Street Pump Station and the Encina Wastewater Authority treatment plant. The pipe was originally constructed in Jefferson Street.
- Preliminary analysis indicates that the rupture was due to external corrosion even though the pipe was plastic coated.
- The pipeline was constructed in 1982, and corrosion appeared isolated within the exposed section of the line.
- Approximately 7.3 million gallons of wastewater spilled to the east basin of Buena Vista Lagoon from sometime Sat. March 31 to approximately 1pm April 2.

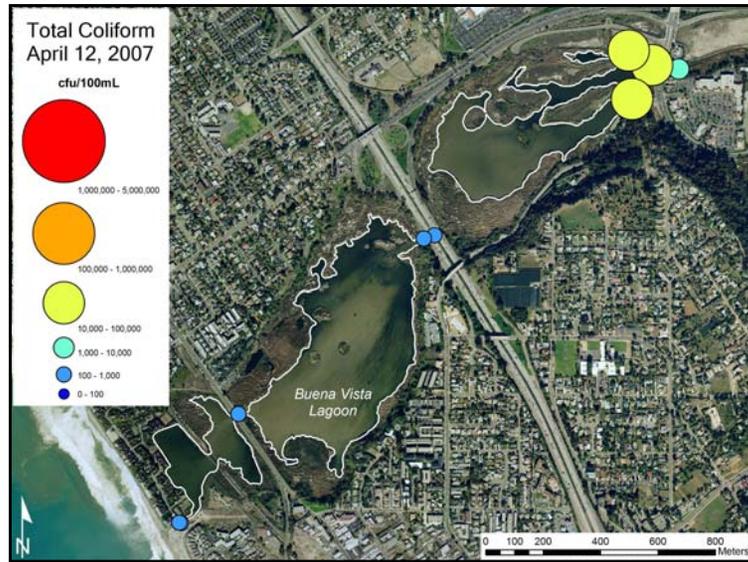
TOTAL COLIFORM

Human Health Standard <10,000

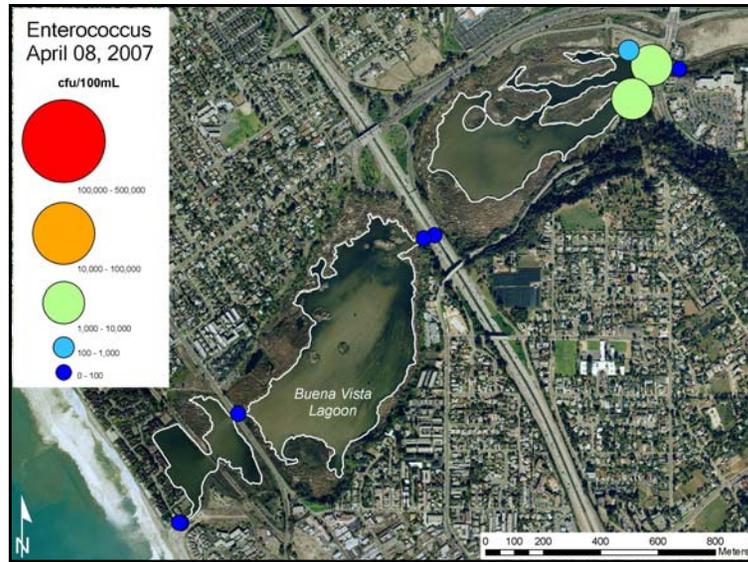
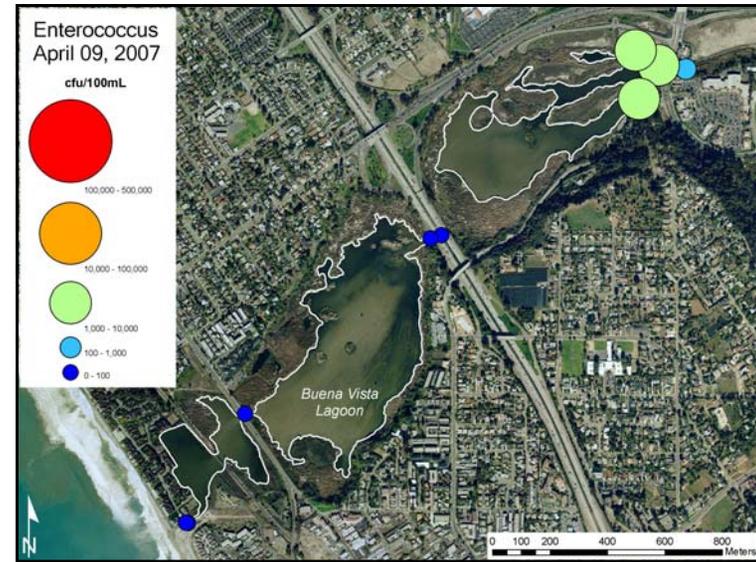
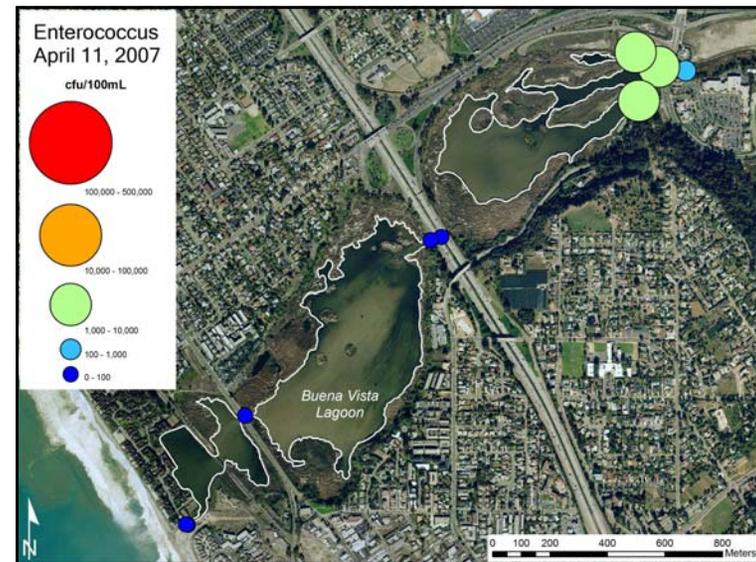
ENTEROCOCCUS

Human Health Standard <104
