File: HUMBOLDT COUNTY 1973

BRIDGE REPORT

REDWOOD CREEK
Humboldt Co. Road 6L200
(Chezem Road)

Bridge No. 4C-121
Post Mile 1.49

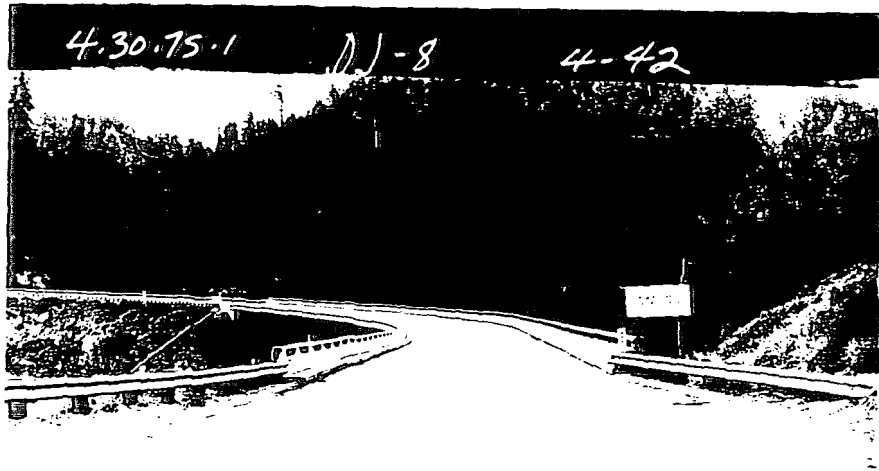
Roadway view looking ahead
